# Select Home Inspections

## Property Inspection Report

Property address: **1234 Sample, Street Myrtle Beach, SC 29588**

Inspection date: **Sunday, April 12, 2015**

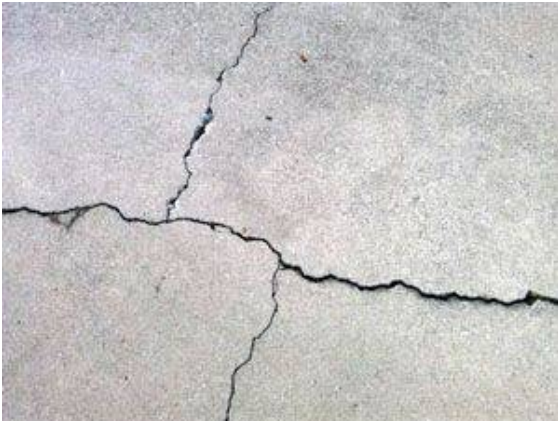
Photo 5-1

Cracks, holes, settlement, heaving and/or deterioration were found in the driveway. Recommend that qualified contractor repair as necessary.

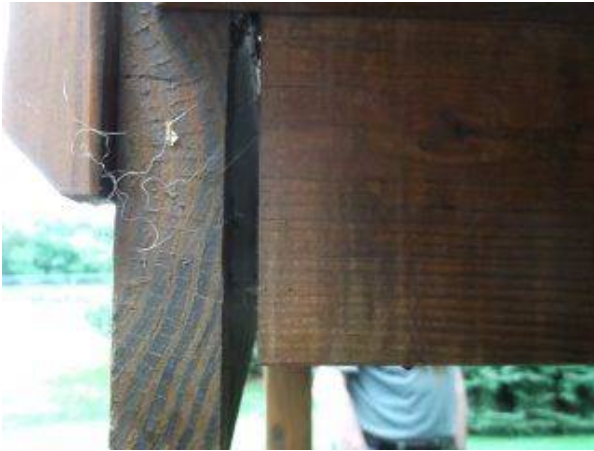
Photo 6-1

Some nails securing decking boards were loose and were not flush with the surfaces of boards. Boards are more likely to loosen and warp. This may pose a safety hazard to those with bare feet. Recommend that a qualified person repair as necessary. For example, by replacing nails or installing screws. Note that existing nails that are simply pounded back in will be likely to loosen again.

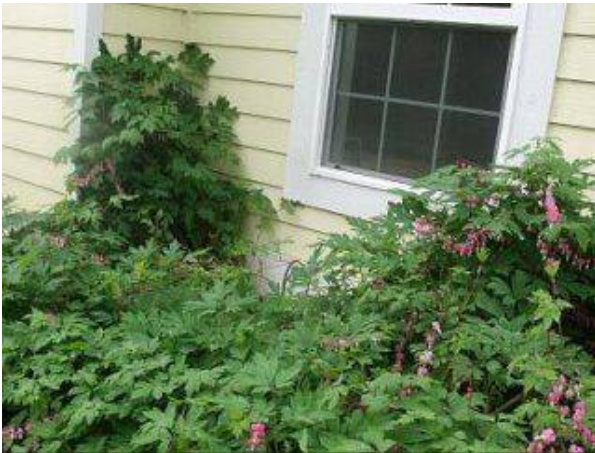
Photo 13-1

Vegetation such as trees, shrubs and/or vines was in contact with or close to the building exterior. Vegetation can serve as a pathway for wood-destroying insects and can retain moisture against the exterior after it rains. This is a conducive condition for wood-destroying organisms. Recommend pruning, moving or removing vegetation as necessary to maintain at least 6 inches of space between it and the building exterior. A 1-foot clearance is better.

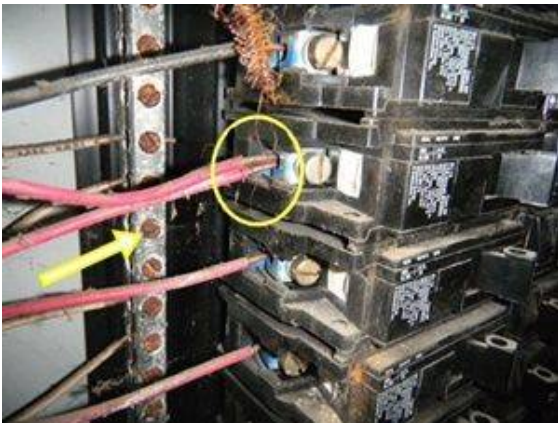
Photo 24-1

One or more circuit breakers in panel(s) #C were "double tapped," where two or more wires were installed in the breaker's lug. Most breakers are designed for only one wire to be connected. This is a safety hazard since the lug bolt can tighten securely against one wire but leave other(s) loose. Arcing, sparks and fires can result. Recommend that a qualified electrician repair as necessary. For more information, visit: <http://www.reporhost.com/?DBLTAP>

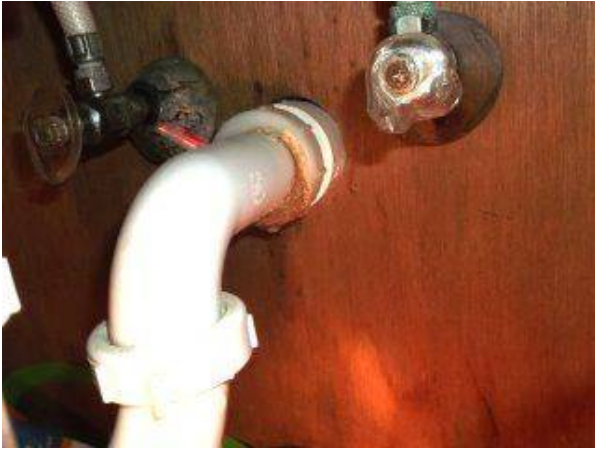
Photo 27-1

One or more leaks were found in drain pipes or fittings. A qualified plumber should evaluate and repair as necessary.

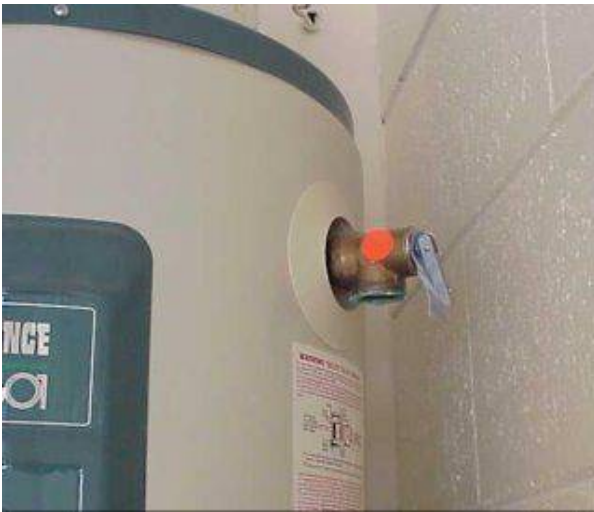
Photo 28-1

No drain line was installed for the temperature-pressure relief valve. This is a potential safety hazard due to the risk of scalding if someone is standing next to the water heater when the valve opens. Recommend that a qualified plumber install a drain line per standard building practices.

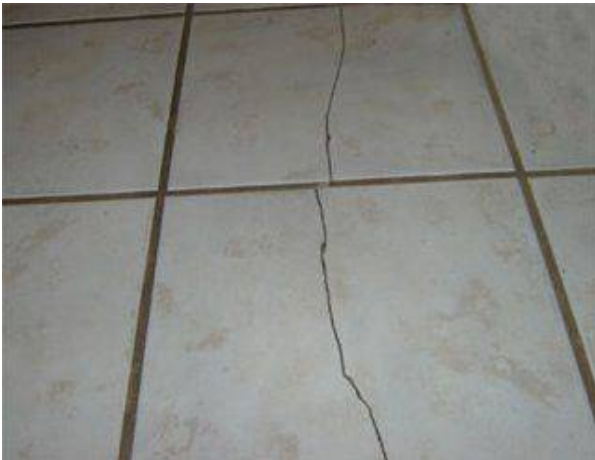
Photo 39-1

Tile, stone and/or grout in the flooring at location(s) #A was deteriorated (e.g. loose or cracked tiles, missing grout) or substandard. Water can damage the sub-floor as a result. Recommend that a qualified contractor repair as necessary.

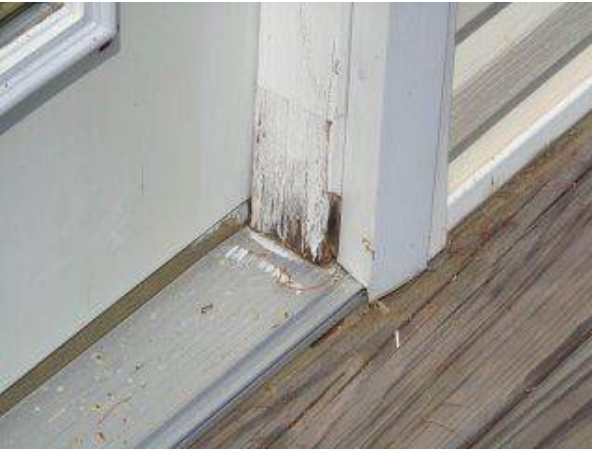
Photo 42-1

42) 🛠️ One or more exterior doors were significantly damaged or deteriorated. Recommend that a qualified person replace door(s) as necessary.
